# Fatigue prone details in steel bridges

M. Al-Emrani<sup>1</sup> & R. Kliger<sup>1</sup>

<sup>1</sup>*Department of structural engineering, Chalmers University of Technology, Göteborg, Sweden*

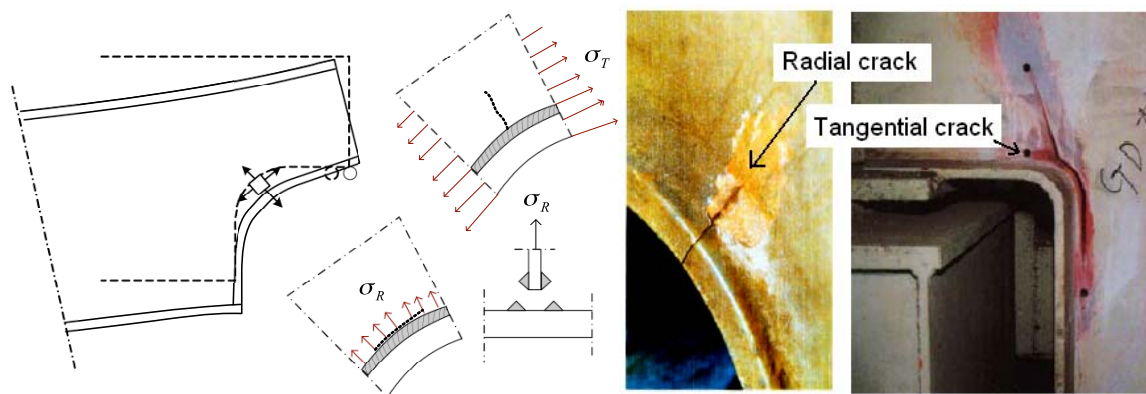
A detail in which numerous fatigue problems have been found in the United States and Japan (see for example Miki et al. (2004)) can be found in Gerber bridges and in bridge girders with reduced depth at the supports. According to beam theory, bending stresses in the girder near the support are negligible and the beam is designed in these locations with respect to shear force alone. Owing to the reduction in girder depth and the resulting change in cross-section, the deformation of the girder will induce additional tangential and radial stresses in the girder web and in the flange-to-web welds along the curvature of the out-cut, see Figure 1.

Damage cases involving fatigue cracking in the web of the girder, as well as in the flange-to-web welds, have been reported. In the latter case, the connection between the flange and web was made by means of fillet welds. The cracks in the girder web can grow either in a direction tangential to the flange curvature (caused by the radial stress component) or in a radial direction (generated by the tangential stress component), see Figure 1.

Figure 1. Tangential and radial stresses in beams with reduced depth and the three cracking modes that can be obtained in this detail and examples of radial and tangential cracks.

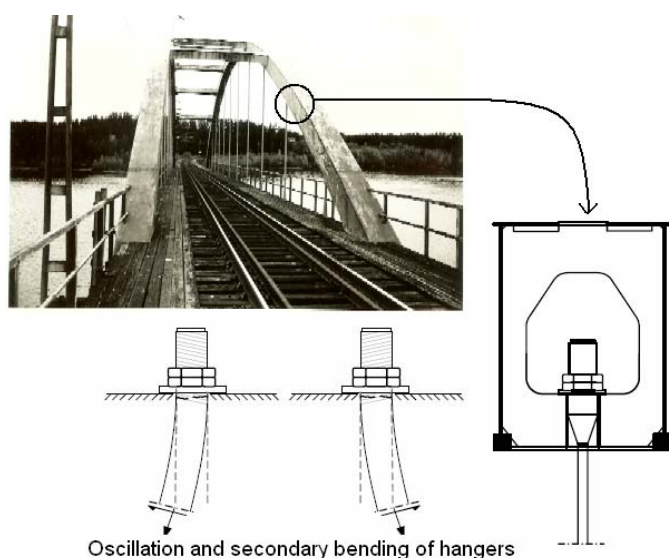
Figure 2 shows an example of an arch bridge in which the hangers have developed fatigue cracking at their connections to the steel arch. This railway bridge, which was built in 1943, has a span of 61 m and comprises a steel arch with two ties (stiffening girders) connected by floor beams. The hangers were made of steel cables with a diameter of 79 mm. A detail of the hanger connection to the steel arch is also shown in Figure 2. The fatigue damage was detected in the early 1980s; some hangers had cracked and had totally separated from their connections to the arch. The cracking which took place at the threaded part of the hanger was attributed to a combination of oscillation and secondary bending of the hangers at their connection to the steel arch.

Figure 2. Fatigue cracking of the hangers in the bridge over Skellefte River in Sweden.

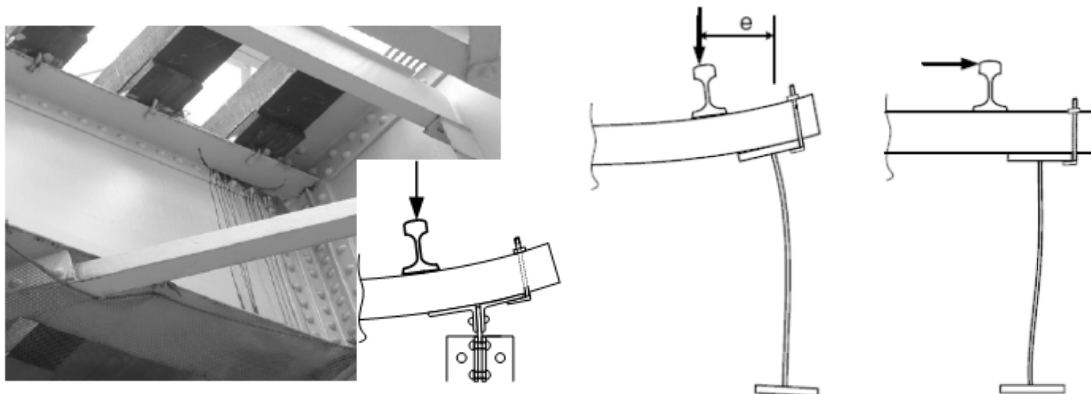
In many old railway bridges, traffic loads on the bridge are transferred to the longitudinal load-carrying members (bridge girders or stringers) via timber ties resting on these members and connected to them by means of hooks or bolts. Several fatigue damage cases in which the stringers exhibited fatigue cracking at locations beneath the timber ties have been reported; Horikawa et al. (2004), Sweeney (1978). In welded girders, the cracks often grow along the toe of the welds connecting the girder web to the upper flange. In older riveted girders, the cracks were found along the fillet of one of the L-profiles forming the upper flange of the girder, see Figure 3.

1. *Bending deformation of the timber ties under the action of vertical axle loads*. The corresponding rotation of the ends of the timber tie forces local bending of the girder flange to which the tie is connected, along with an out-of-plane deformation of the girder web.
2. *Transverse forces on the bridge, causing the out-of-plane bending of the girder web*. This effect is more pronounced in curved bridges, but it can also be induced by different track irregularities in straight bridges.

Figure 3. Example of fatigue cracking in stringers at timber tie connections and the deformations inducing this cracking.

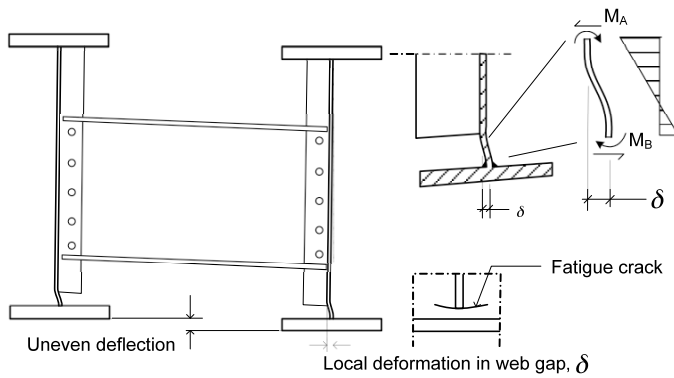
The detail near the termination of transverse plates (or vertical stiffeners) used to connect diaphragms or the cross-bracing is known to be one of the most critical in terms of fatigue in steel bridges. Fatigue cracking here is primarily found in the girder web, starting at the end of the stiffener and growing almost horizontally in a direction parallel to the normal bending stresses in the web, see Figure 4. This type of fatigue cracking has been reported in both railway and highway bridges and can be found in many bridge types, including two- and multi-girder bridges, box girder bridges and truss bridges. The mechanism behind fatigue cracking at diaphragm and cross-bracing connections is, however, the same, irrespective of bridge type. Loading cases, which result in secondary bending of the bridge girders (in the weak direction) and/or torsional deformation of the bridge cross-section, cause uneven deflection of the girders, which is resisted by the diaphragm or the cross-bracing elements. Consequently, tensile and compressive forces are generated in these elements, acting perpendicular to the plane of the girder web and causing secondary bending stresses which are localized in the unstiffened part of the web between the girder flange and the end of the connection plate, see Figure 4.

Figure 4 The differential deflection of bridge girders results in high local bending stresses in unstiffened web gaps between the girder flange and the termination of cut-short connection plates.

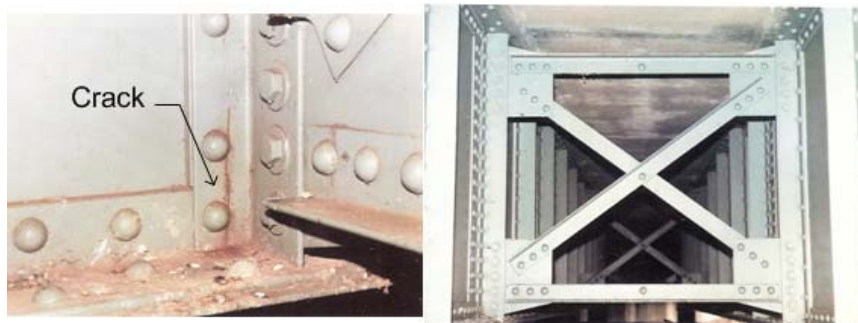
Furthermore, riveted connections of the type discussed here have also been shown to be prone to fatigue cracking; Yen et al. (1990). In this case, the fatigue damage was found either in the outstanding leg of the connection angle or in the rivets connecting the angle to the girder web, see Figure 5.

Figure 5 Fatigue cracking in the riveted connection of cross-bracing elements.

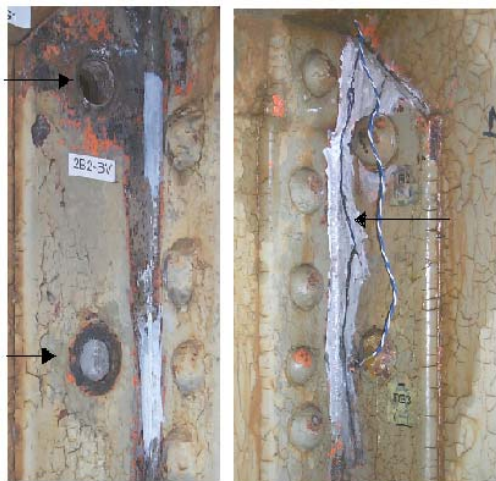
Figure 6. Examples of fatigue damage in riveted stringer-to-floor-beam connections.

Connections of this type have displayed large-scale vulnerability to fatigue cracking. A large number of cases of damage in which fatigue cracks were detected in the connection angles have been reported; Al-Emrani (2002), Al-Emrani et al. (2004). The cracks usually start in the outstanding leg of the connection angle and grow along the fillet of the angle. Figure 6 shows an example of this kind of fatigue cracking. In old riveted connections, rivet failures are also very common. Cracking here starts in the junction between the rivet head and shank (caused by prying and rivet bending) and finally results in the total separation of the rivet head. Fatigue damage of this kind is generally located at the top of the connection, but cases of damage with fatigue cracking and/or rivet failure at the bottom of the connection have also been reported; Al-Emrani (2002).

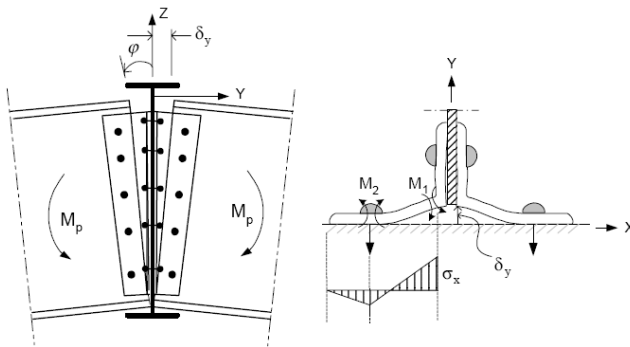
1. *The rotation of stringer ends associated with bending.* Even though double-angle connections were designed as simple shear connections, it is generally inevitable that these connections also acquire some rotation stiffness, thus partially restraining the rotation of stringer ends. Consequently, negative bending moment will develop at the ends of the stringers, subjecting the fasteners and the angles of the connections to load effects which are not taken into account during design, see Figure 7. This kind of action has a relatively short influence line, giving rise to a large number of loading cycles during the service life of the bridge.

Figure 7. Secondary bending at stringer ends due to restrained end rotation. Bending and axial stresses at the top of the stringer-to-floor-beam connection might be high enough eventually to result in fatigue cracking.

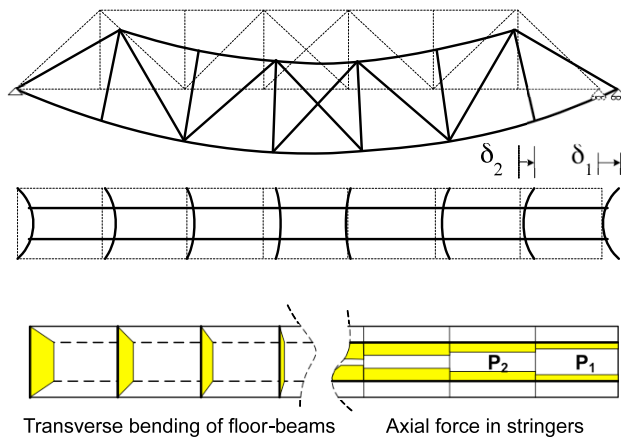
2. *An overlooked interaction between the floor system (stringers and floor beams) and the main load-carrying structure (main girders or main trusses, for example).* Bending deformation of the main truss bridge, for instance, involves the longitudinal displacement of the truss joints to which the floor beams are connected. The floor beams are, however, partially restrained from following this deformation due to the axial stiffness of the stringers and their connections to the floor beams. As a result, secondary axial forces will develop in the stringers and their connections to the floor beams, while the latter will be subjected to secondary bending (in the weak axis), see Figure 8. This kind of interaction has an influence line, which is equal to the span of the bridge and, in the case of railway bridges, there is essentially one loading cycle every time a train passes.

Figure 8. The interaction between the floor system (stringers and floor beams) and the main bridge trusses results in secondary axial forces and bending moment in the stringers and the floor beams respectively.

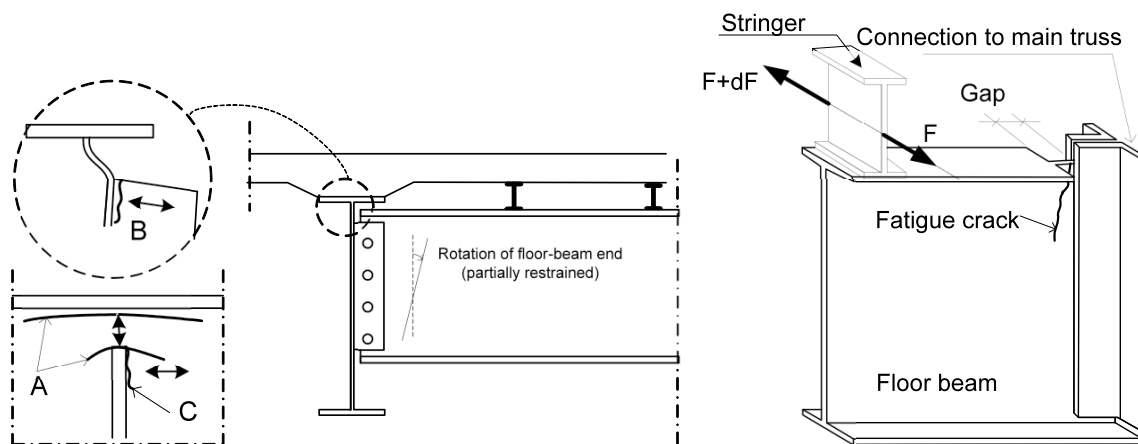
Figures 9 show two examples of fatigue cracking caused by the restrained rotation of floor-beam ends. In mechanically fastened connections, the fatigue damage is generally found in the connection angles or the rivets (or bolts) connecting the angles to the main load-carrying element; International Institute of Welding, Shenton et al. (2003). In welded details, where the floor beam is connected to a welded transverse plate, cracking has been reported in the main girder web (types A and C in Figure 9) or in the connection plate along its fillet weld to the main girder web (type C); International Institute of Welding, Yen et al. (1990), Fisher (1984).

The second type of interaction (transverse bending of the floor beams) has also resulted in fatigue damage in many steel bridge types. One example is shown in Figure 9. In this case, the upper flange of the floor beam is cut short near the floor beam to main truss connection, leaving a small – locally flexible – gap in the floor-beam web where the deformation is concentrated. The same kind of fatigue cracking has been reported for highway girder bridges by Yen et al. (1990), Fisher (1984), in truss bridges, International Institute of Welding, and in arch bridges; Shenton et al. (2003).

Figure 9. Fatigue cracking by the two different interaction types in floor-beam to main girder connections.
